Number
National Dam Inspection Program, Crystal Lake Dam (NDS ID#562), Susquehanna River Basin, Wapwallopen Creek, Luzerne County, Pennsylvania, Phase I Inspection Report.

CRYSTAL LAKE DAM

PHASE I INSPECTION REPORT

⑪ MAY 1978

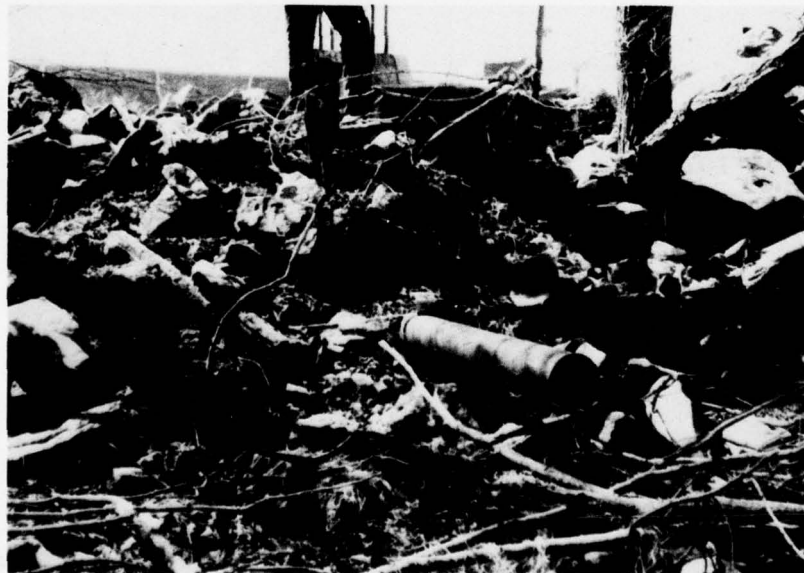
B. Blowoff Pipe and Riser Pipe for Valve

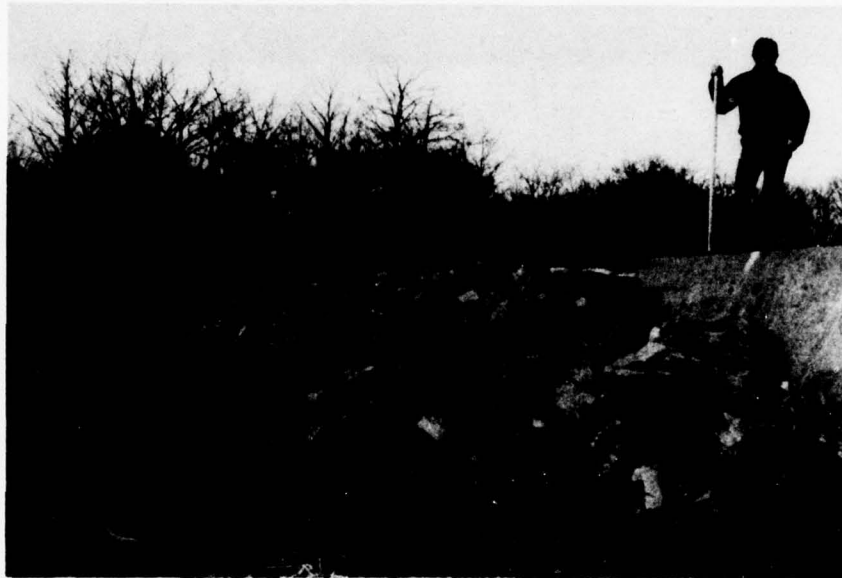
C. Right Abutment Dike
Nonoverflow Section at Right
